Mechano-Chemical Polishing of Alloy 600 for Accelerated Crack Initiation in Simulated PWR Primary Water Environment and Three-Dimensional Crystallographic Characterization

Ki-Taek Jung, Hiroaki Tsuchiya and Shinji Fujimoto

In this study, we propose a simple approach to accelerate crack initiation in intergranular stress corrosion cracking (IGSCC) of Alloy 600 in a simulated pressurized water reactor (PWR) primary water environment. In addition, we perform three-dimensional crystallographic characterization of the crack initiation by electron backscatter diffraction (EBSD). Initiation of IGSCC of the alloy in the PWR primary environment was realized for a flat tensile specimen in a considerably short time through a slow strain rate test (SSRT). The accelerated initiation was attributed to the asperity of the alloy surface induced by mechano-chemical polishing with colloidal silica suspension before the SSRT was conducted. Following the SSRT, the specimen surfaces were covered with thick oxide films, which prevented EBSD measurements. The sputtering of thick oxide films enabled us to characterize cracks with EBSD, thus yielding important information on IGSCC. Finally, an approach f

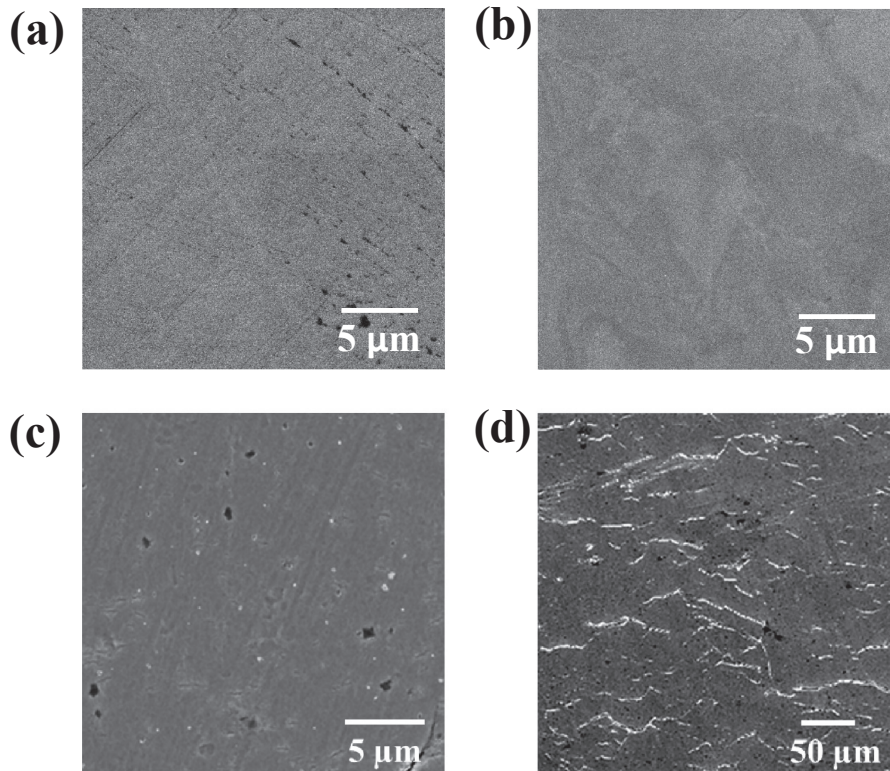
Fig. 1 SEM images of Alloy 600 surface (a), (b) before and (c), (d) after an SSRT in the simulated PWR primary environment: (a), (c) without polishing by colloidal silica suspension, (b), (d) with polishing by colloidal silica suspension.

Figure 1 shows typical SEM images of Alloy 600 surfaces before and after SSRTs were conducted in the simulated PWR primary environment. The alloy specimen shown in the images was cold-worked with a reduction rate of 20% prior

to the SSRTs. In the SSRTs, the specimens were elongated once up to the tensile strain of 10% and then the strain was released. In other words, the specimen was not held under the strain for 50 h in this case. As shown in Fig. 1(c), practically no cracks were observed for the specimen polished without colloidal silica suspension. By contrast, as shown in Fig. 1(d), many cracks were formed on the specimen polished with colloidal silica suspension. The initiation of IGSCC on Alloy 600 was already achieved by Totsuka *et al.*²⁸⁾ on a tensile specimen in a laboratory experiment, but a ridge was introduced on the gauge section of the tensile specimen to enhance the initiation of IGSCC. To the best of our knowledge, this study is the first case in which the initiation of IGSCC was realized by SSRT on a “flat” tensile specimen of Alloy 600. We previously reported that intergranular cracks were initiated on a non-sensitized Type 316L stainless steel during an SSRT in a dilute sodium sulfate solution at 561 K.²⁹⁾ The surface of the stainless steel was also polished with colloidal silica suspension prior to the SSRT. This indicates that polishing with colloidal silica suspension facilitates the initiation of IGSCC. By contrast, the transgranular stress corrosion cracking (TGSCC) occurred on the non-sensitized stainless steel polished without colloidal silica suspension under the same condition.²⁹⁾

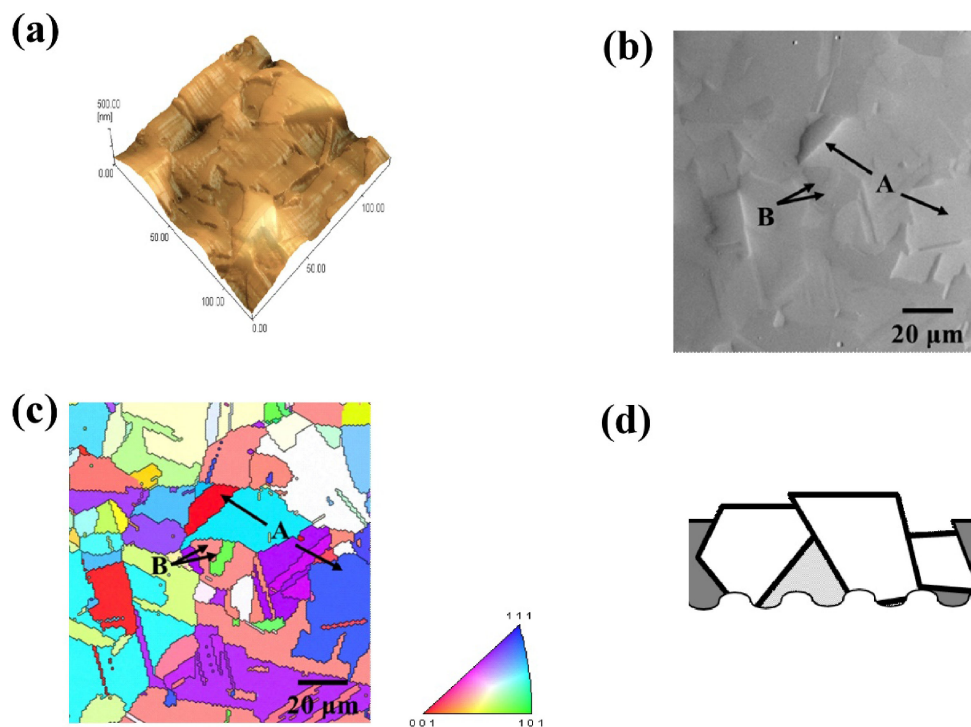
Fig. 2 (a) AFM image of Alloy 600 surface prior to the SSRT, (b) topography and (c) IPF map obtained at the same location, (d) schematic drawing of cross-view of grains near the alloy surface.

Figure 2(a) presents an AFM image of the surface of Alloy 600 specimen prior to the SSRT. The image reveals an uneven textured surface of the alloy. However, no trenches were formed at the grain boundaries. The back scattered electron (BSE) image and inverse pole figure (IPF) map obtained at an identical location are shown in Figs. 2(b) and 2(c), respectively. The images clearly show that the surface asperity reflects crystallographic orientation, which is consistent with the observation for Alloy 22.³⁰⁾ It was found

that crystallographic orientation causes different dissolution rates of the alloy substrate during its mechano-chemical polishing with colloidal silica suspension, which results in this asperity. The asperity indicates that small steps are present at the grain boundary as schematically shown in Fig. 2(d). These small steps cause stress concentration at the grain boundary, leading to crack initiation. Therefore, it can be concluded that the microscopic asperity as shown in Fig. 2(a) facilitates the initiation of IGSCC. From these results, one can deduce that the initiation of IGSCC of Alloy 600 under practical operation might be attributed to the asperity generated as general corrosion by the long-term exposure to a PWR primary environment because of the difference in the dissolution rate based on the crystallographic orientation of grain.

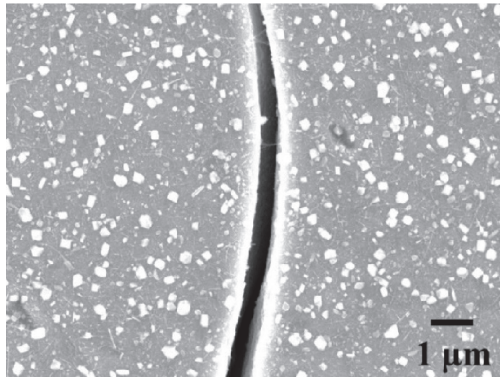
Fig. 3 SEM image of a crack formed on the Alloy 600 surface following an SSRT in the simulated PWR primary environment.

Although this work was conducted to examine the crack initiation on Alloy 600 in a simulated PWR primary environment based on crystallographic information, this type of information could not be obtained from the specimen immediately following the SSRT. As shown in Fig. 3, the specimen surface was covered with an oxide film and many corrosion products. Based on our previous study,²³⁾ a relatively thick oxide film was formed on the mill-annealed Alloy 600 during 24-h immersion in a similar PWR primary water environment. In the study, the thickness of the oxide film was estimated to be approximately 24 nm from the intensity attenuation of the Ni metallic peak of the substrate in the hard X-ray photoelectron spectra. The oxide film formed during the SSRT in this study was thicker than the previously reported oxide film on the mill-annealed Alloy 600. This was because the exposure time of Alloy 600 to the simulated PWR primary environment in this work was much longer than that in the previous work. The thick oxide film on

the Alloy 600 surface prevented the measurement of electron-backscatter patterns from the underlying substrate. Therefore, the oxide film formed under the high-temperature and high-pressure water environment was removed by Ar^+ ion sputtering.

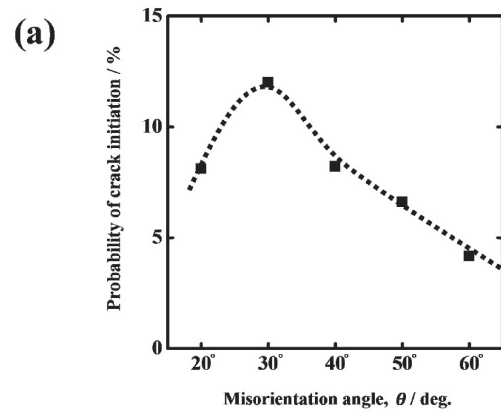
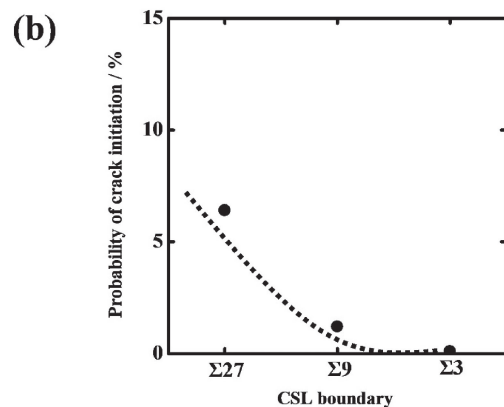
Fig. 5 Probability of crack initiation calculated for random and CSL boundaries against various misorientation angle ranges estimated with EBSD.

Figure 5 summarizes the probability of crack initiation calculated for the grain boundary with respect to the misorientation angle at the grain boundary. The probability of crack initiation was defined as the ratio of the number of cracked grain boundaries to the total number of grain boundaries for each range of misorientation angle. Furthermore, the probability can be summarized for the two categories of grain boundaries, that is, the random and coincidence site lattice (CSL) boundaries. On the alloy used

in this work, three types of CSL boundaries, namely $\Sigma 3$, $\Sigma 9$, and $\Sigma 27$, were recognized, with the calculated misorientation angles of 60° , 38.9° , and 31.6° , respectively. The figure indicates that the probability of crack initiation strongly depends on the type of grain boundary. In other words, cracks initiate more readily at the random grain boundary than at the CSL boundary. In addition, for the random boundary, the probability of crack initiation is higher for the misorientation angles ranging from 30° to 40° as compared to the other ranges of misorientation angles. By contrast, the probability of crack initiation increases with an increasing Σ value for the CSL boundary.

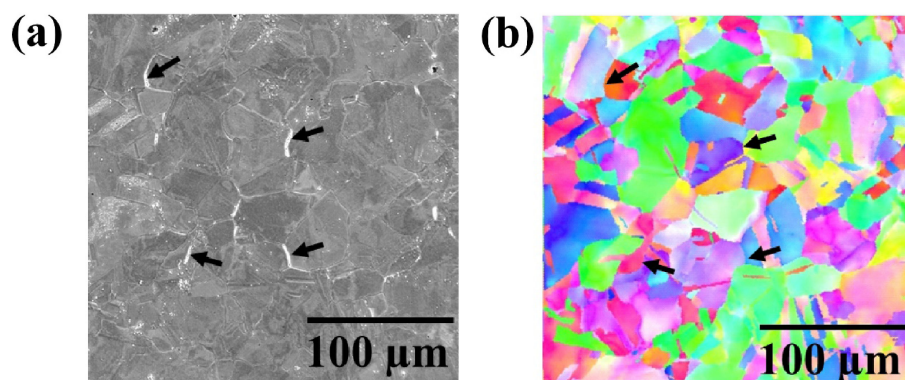
Fig. 4 (a) SEM image of the Alloy 600 surface after corrosion products formed during the SSRT were removed by sputtering, (b) IPF map obtained at the same location shown in (a).

Figure 4(a) shows the SEM image of the Alloy 600 specimen after sputtering. Note that the horizontal direction of the image is parallel to the loading axis of the SSRT. It was evident that the thick oxide film and corrosion products were removed by sputtering, and cracks were clearly observed on the surface after sputtering. More importantly, all cracks were observed at the grain boundaries, indicating that IGSCC occurred on the alloy. Furthermore, many of the cracks initiated approximately perpendicular to the stress axis. Figure 4(b) shows the IPF map of the same location shown in Fig. 4(a). A clear IPF was obtained for the surface of the Alloy 600 specimen after the SSRT. Analysis of crystallographic data with the corresponding SEM image reveals the crystallographic features of IGSCC.

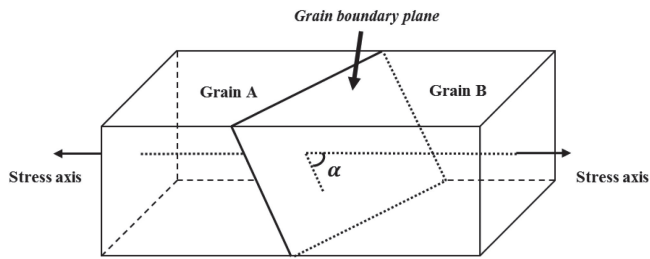
Fig. 6 Definition of grain-boundary-plane angle introduced in the present work. The stress axis is parallel to the rolling direction.

Because the IGSCC cracks initiated and propagated along a grain boundary, gaining information about the grain boundary plane is important to understand the initiation and propagation of cracks. In this study, as illustrated in Fig. 6, the angle between a grain boundary plane and the stress axis was defined as grain-boundary-plane angle, assuming that a grain boundary was flat. However, the direction of the crack could not be determined by an SEM observation, as it was performed only for the upmost surface of the specimen. Therefore, we proposed a three-dimensional characterization of crack initiation, which was realized by repeated polishing and EBSD measurements. First, an EBSD measurement was conducted for the topmost surface after the sputtering as previously mentioned. Then, the surface was gently polished with colloidal silica suspension to remove a layer of approximately 1- μm in thickness from the specimen surface. This resulted in the displacement of the grain boundary based on the angle of the grain boundary plane to the surface. From the displacement of the grain boundary and the thickness of the removed specimen surface, the grain-boundary-plane angle was computed using a trigonometric function. In order to measure the displacement of the grain boundary, IPFs obtained at two different depths were used. Triangular pyramidal indentations were introduced as markers to

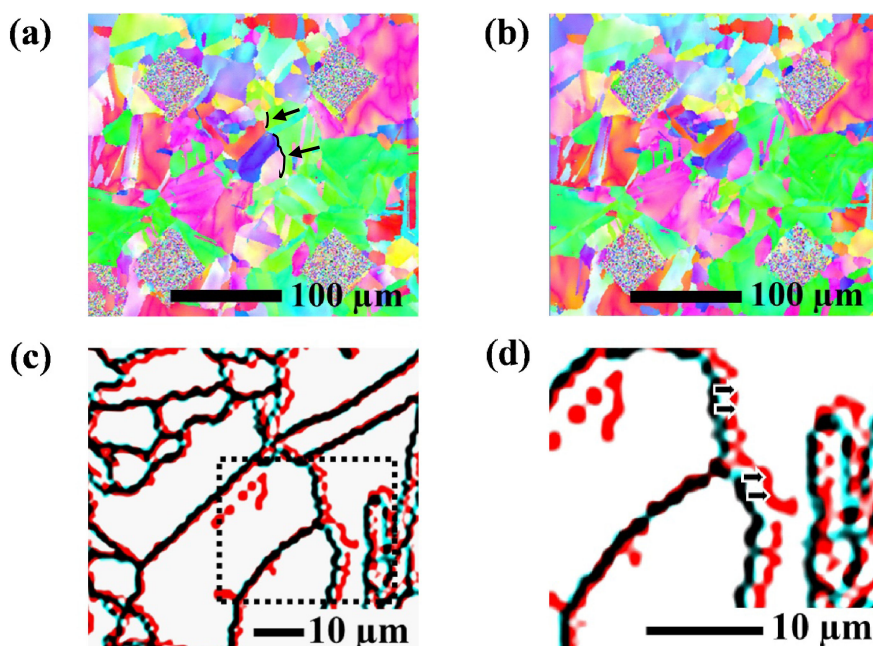
Fig. 7 IPF and grain-boundary maps obtained at the same location on the specimen before and after gentle polishing. The arrows in (a) indicate locations where crack initiated.

IPFs obtained at the same location on the specimen surface before and after gentle polishing are presented in Fig. 7. The grain boundary positions before and after gentle polishing were extracted from the IPFs and are shown to overlap in Fig. 7(c). Figure 7(d) presents a magnified image of the site indicated by the square in Fig. 7(c). The black and red lines in the images indicate the grain boundaries before and after gentle polishing, respectively. As can be seen, some red lines coincide with the black lines, whereas the other red lines deviate from the corresponding black lines. The distance between the lines reflects the displacement of the grain boundary. Using the displacement at each boundary and the removed thickness, we calculated the grain-boundary-plane angle, which is summarized in Fig. 8. Figure 8 presents correlation between the grain-boundary-plane angle and the misorientation angle described above. As presented, more cracks were recognized at the random boundary than at the CSL boundary. Lehockey *et al.* reported a similar result in which a crack appeared exclusively confined to the random boundary rather than at the CSL boundary.³¹⁾ Around the misorientation angle of 40° for the random boundary, cracks initiated within a wide range of grain-boundary-plane angle. For other misorientation angle ranges, cracks initiated at the grain-boundary-plane angles of approximately 40°. A similar trend was observed for the CSL boundary as shown in Fig. 8(b), that is, cracks initiated at the grain-boundary-plane angle of approximately 40°, independent of the CSL boundary. Alexandreanu *et al.* examined the stress corrosion cracking of Alloy 600 in a simulated PWR environment and the deformation behavior of the alloy in Ar environment at 633 K. They compared the distribution of calculated shear stress on grain boundary plane with the distributions of fraction of deformed as well as cracked high-angle boundary

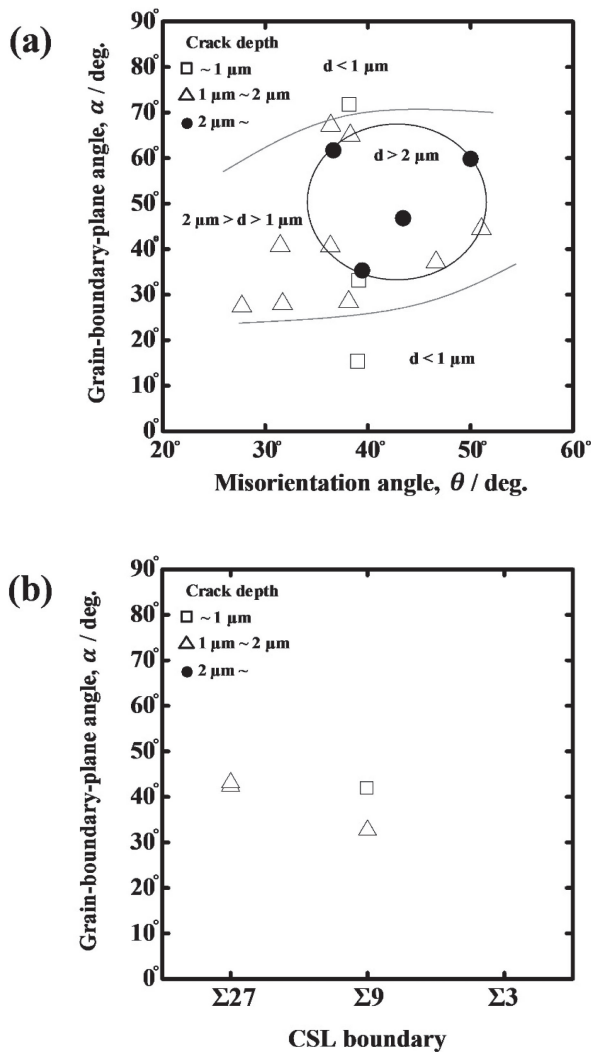
Fig. 8 (a) Correlation between misorientation angle and grain-boundary-plane angle obtained for cracked random boundary. (b) Correlation between type of cracked CSL boundary and grain-boundary-plane angle.

against the angle with respect to the tensile direction, that is, the grain boundary plane angle as defined in the present work.³²⁾ They found that the calculated shear stress exhibited the similar distribution to the deformed boundary in Ar and the cracked boundary in the PWR environment, that is, they increased with increasing the grain boundary plane angle of 45° and then decreased with the angle, that is, the distribution of cracked boundary is roughly in accordance with Fig. 8. These results indicated that the shear stress may be a driving force not only for the grain boundary deformation but also for IGSCC. Although further analysis is required to discuss in more detail the mechanism of SCC crack initiation in terms of the crystallography of the grain boundary, the results of the present study indicate that the proposed approaches can facilitate the initiation of IGSCC and provide crystallographic information of grain boundaries on the surface as well as inside the alloy.
